## ASBESTOS RE-INSPECTION SURVEY REPORT

WAREHOUSE 1  
GSA BUILDING NUMBER WA0824KF  
2701 C STREET SW  
AUBURN, WASHINGTON

ASSESSMENT DATE:  
09-10- 2012

PREPARED BY:  
UNITED STATES PUBLIC HEALTH SERVICE  
FEDERAL OCCUPATIONAL HEALTH SERVICE  
DALLAS AREA OFFICE  
1301 YOUNG STREET, SUITE 772  
DALLAS, TX 75202

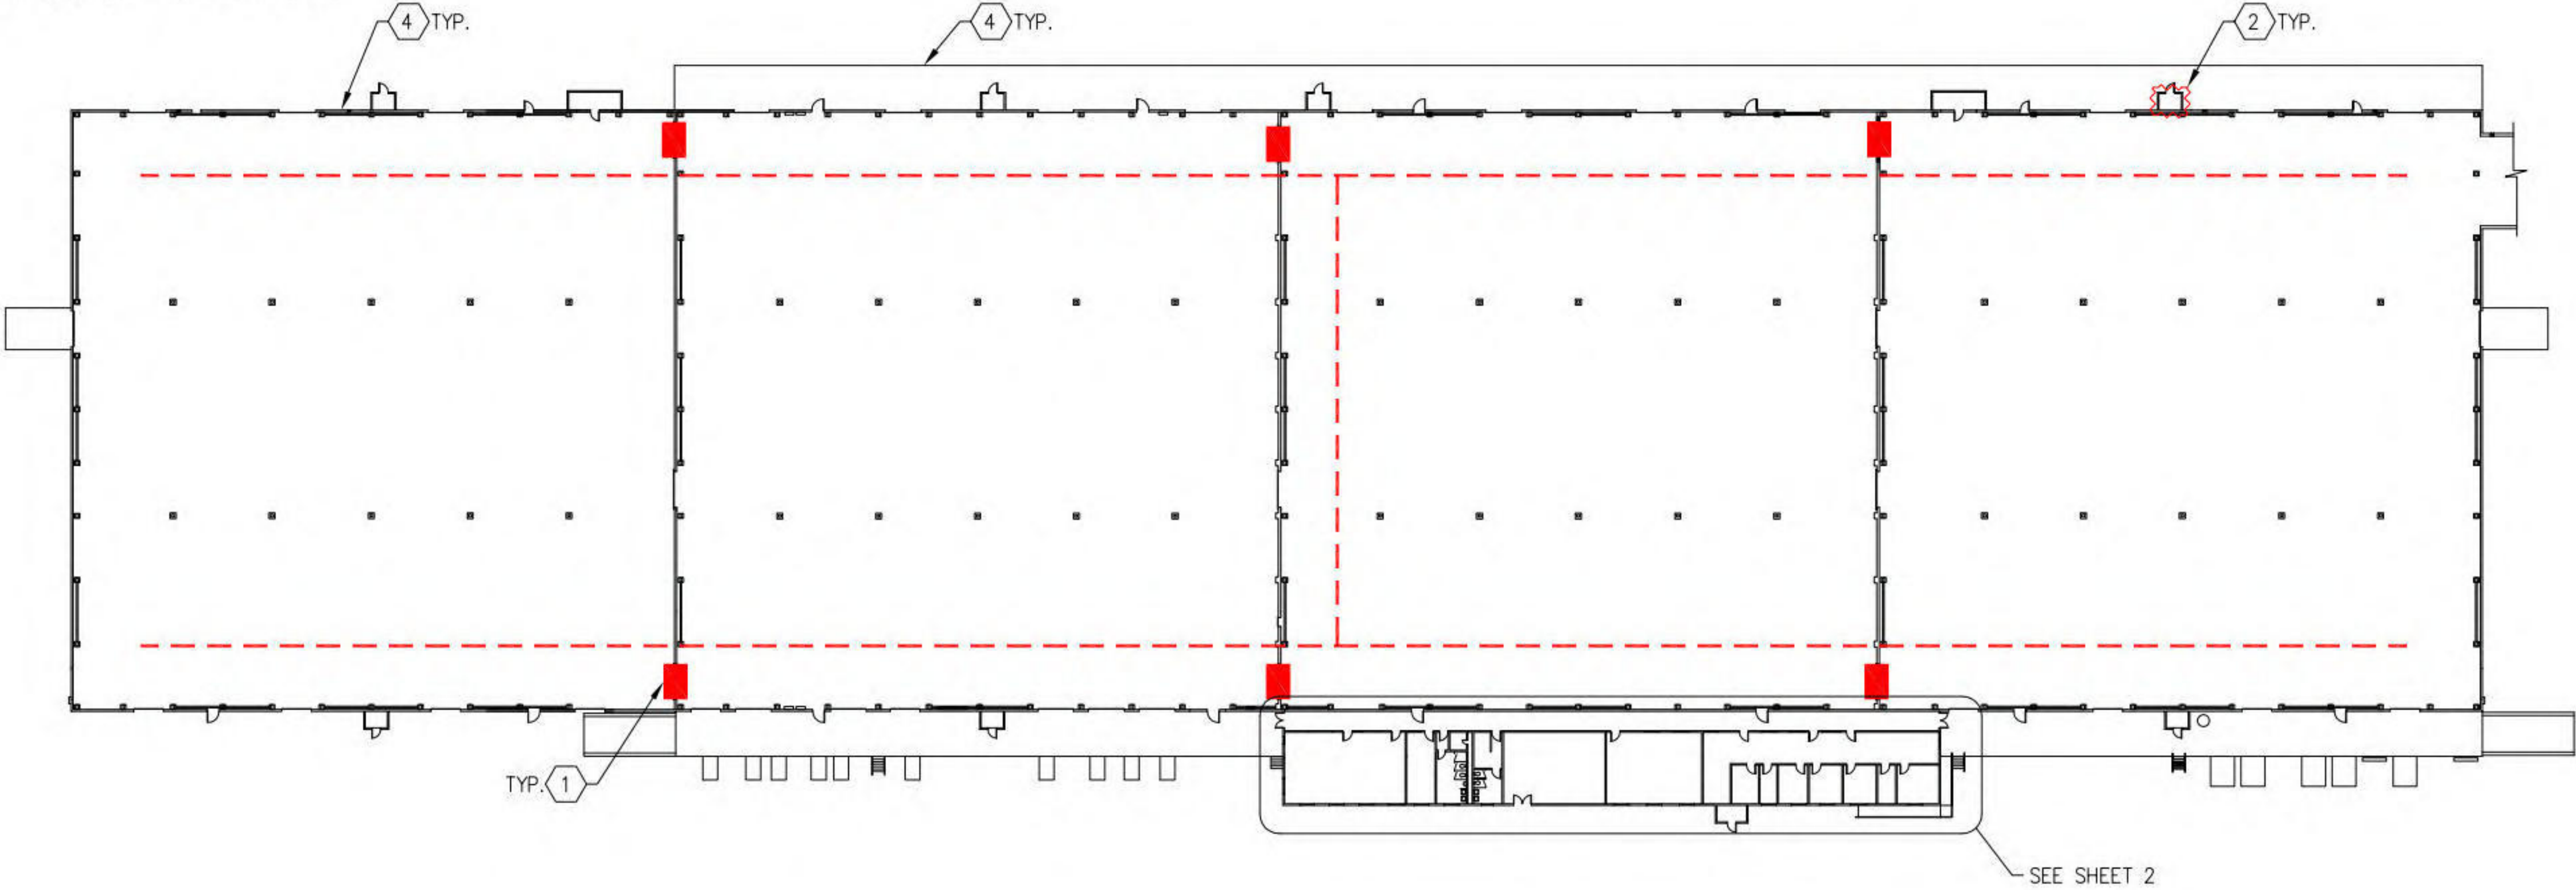
1ST FLOOR PLAN  
MATERIAL LOCATIONS  
SCALE: NTS

- 1 ASBESTOS CONTAINING CORE FIRE DOORS. INTERNAL FIRE DOORS SEPARATE BAYS AND ARE APPROXIMATELY 10- X 20-FOOT EACH.
- 2 CEMENT ASBESTOS BOARD WALL PANEL LINING.
- 3 ASBESTOS CONTAINING TSI PIPING (INCLUDES FITTINGS)
- 4 CEMENT ASBESTOS BOARD ON EXTERIOR SOFFIT AND ASSUMED ASSOCIATED FELT VAPOR BARRIER PAPER UNDERNEATH.

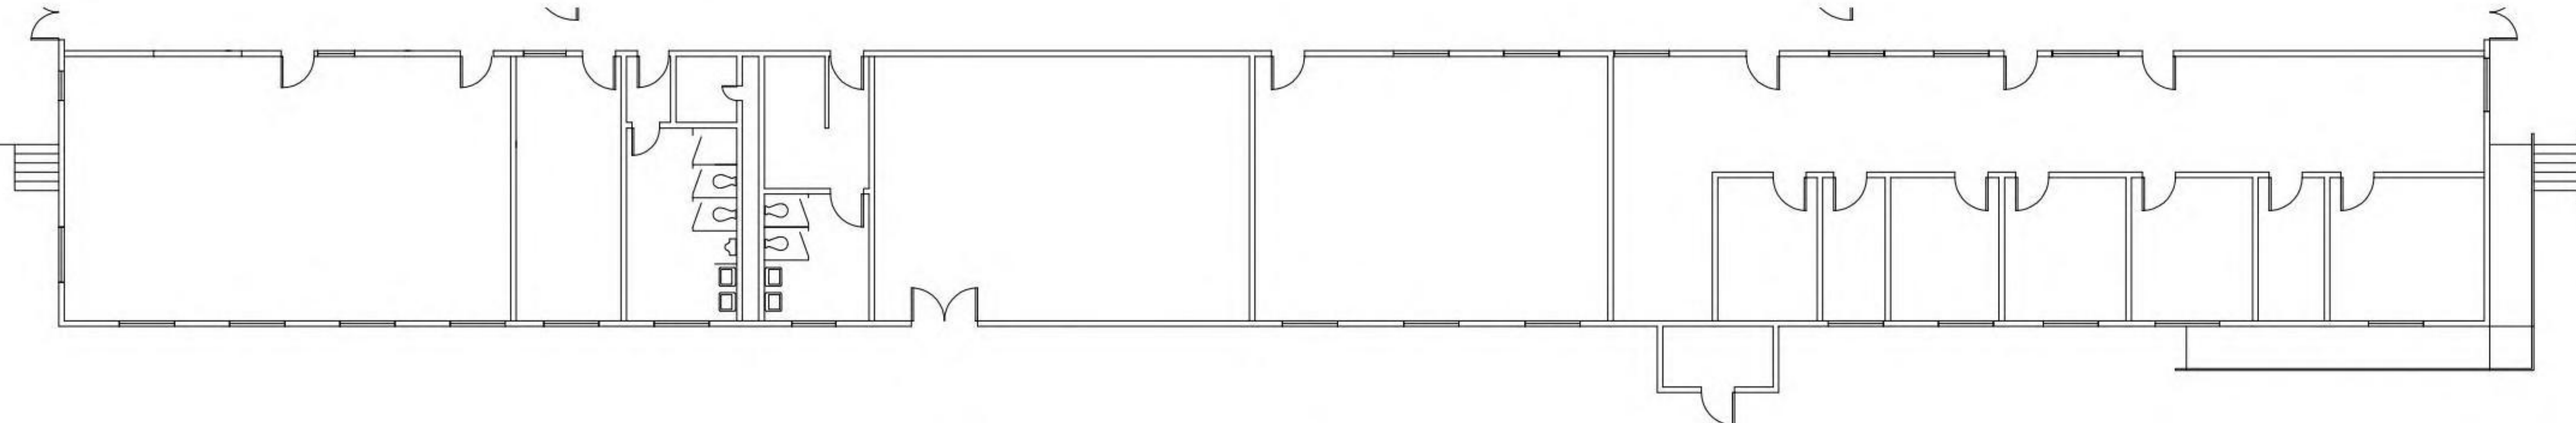
1ST FLOOR PLAN  
MATERIAL LOCATIONS  
SCALE: NTS

- 1 ASBESTOS CONTAINING CORE FIRE DOORS. INTERNAL FIRE DOORS SEPARATE BAYS AND ARE APPROXIMATELY 10- X 20-FOOT EACH.
- 2 CEMENT ASBESTOS BOARD WALL PANEL LINING.
- 3 ASBESTOS CONTAINING TSI PIPING (INCLUDES FITTINGS)
- 4 CEMENT ASBESTOS BOARD ON EXTERIOR SOFFIT AND ASSUMED ASSOCIATED FELT VAPOR BARRIER PAPER UNDERNEATH.
